FOREST PRODUCTS RESEARCH IN PICTURES

NO. 47

**UNPROTECTED DOOR RUINED WHEN
GLUE YIELDS TO WEATHER**

**FOREST PRODUCTS LABORATORY
U. S. FOREST SERVICE
MADISON, WISCONSIN**

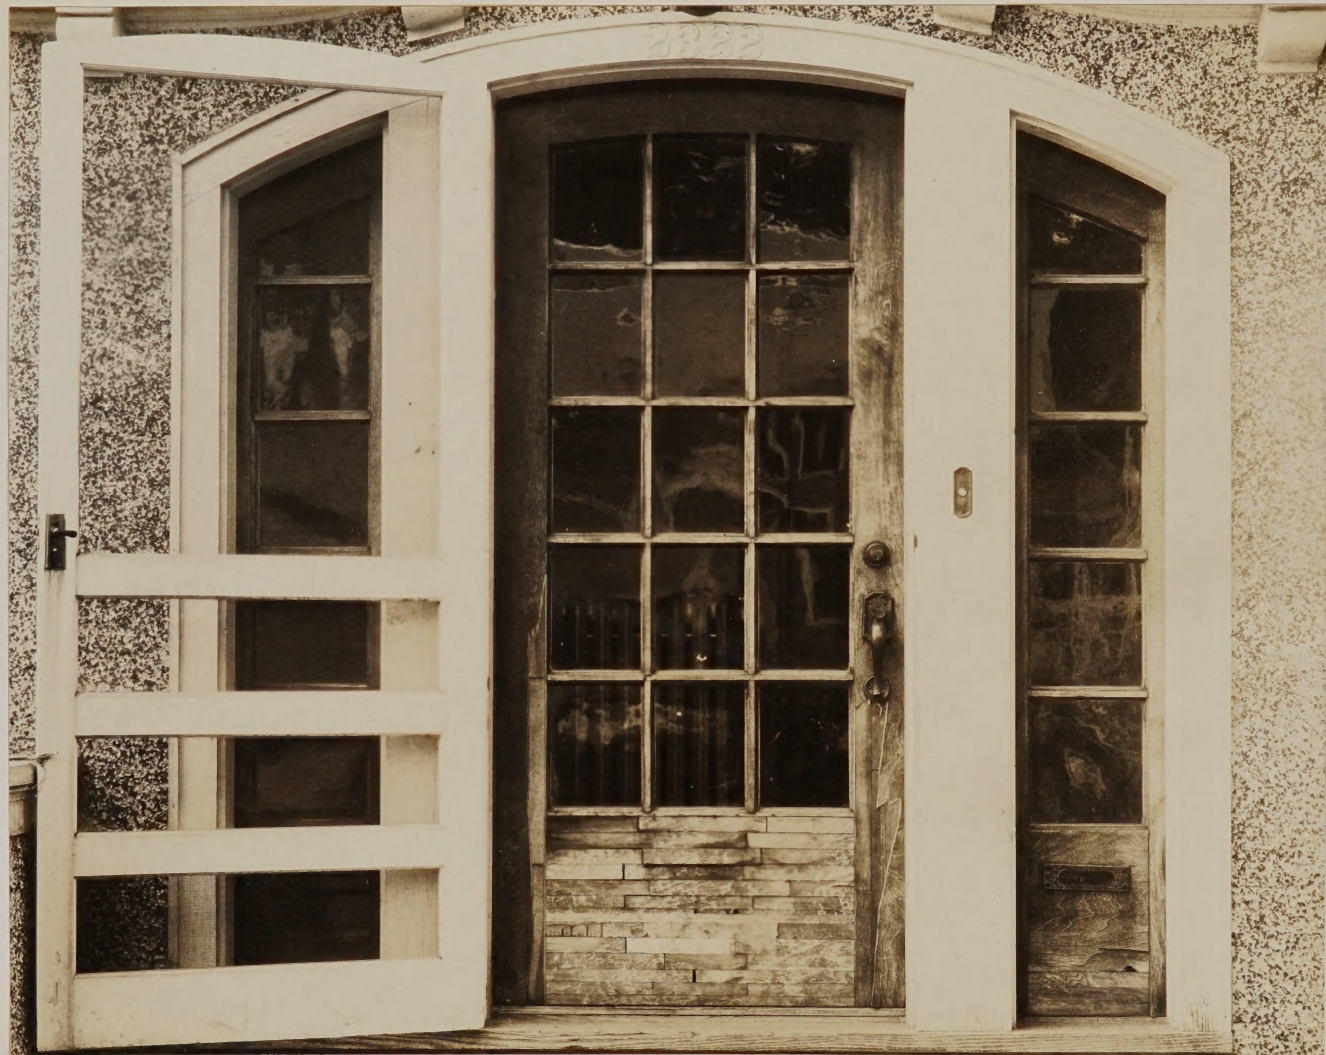
This built-up door, put together with a glue of low moisture resistance, reached the stage of dilapidation shown here in three years. It is on an open porch without a roof or other protection. Some loosening of the veneer had occurred even before the new house was ready for its first tenants. The built-up form of construction used in making most of the doors marketed today is an economical one and generally serviceable but the average door is not built to withstand direct exposure to the weather. Failure of the door pictured here can be traced to the lack of protection, to the faulty glue contact as shown by the spottiness of the peeled area, and to the use of a glue with little moisture resistance. The manufacturer is usually able and willing to supply a door suited to particular needs when he is aware of the conditions which the door is to meet. Carefully regulated gluing conditions and only glues of high water resistance — such as casein glue or blood albumin glue — should be used in the manufacture of built-up doors liable to be exposed to considerable moisture.
